Annual Inspection

East Hertfordshire District Council

Tonwell Recreation Ground (Bengeo PC)

Inspection Ref: 2475598

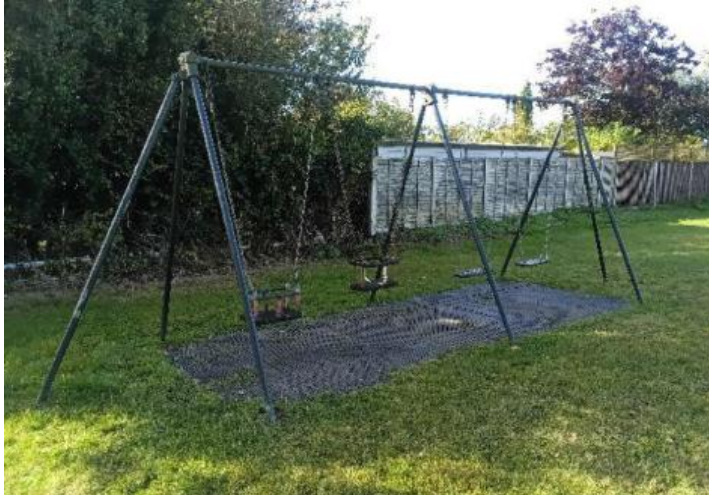
Item: Ancillary Items - Site General
Manufacturer: Owner/Operator

Finding: It is recommended that signage, with information including the site address, contact information for maintenance issues and emergency contact details are provided for the facility

Action: Provide in accordance with the recommendations

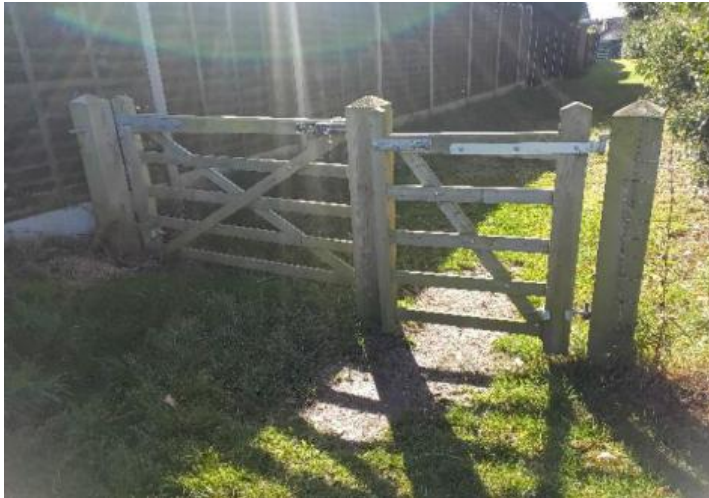
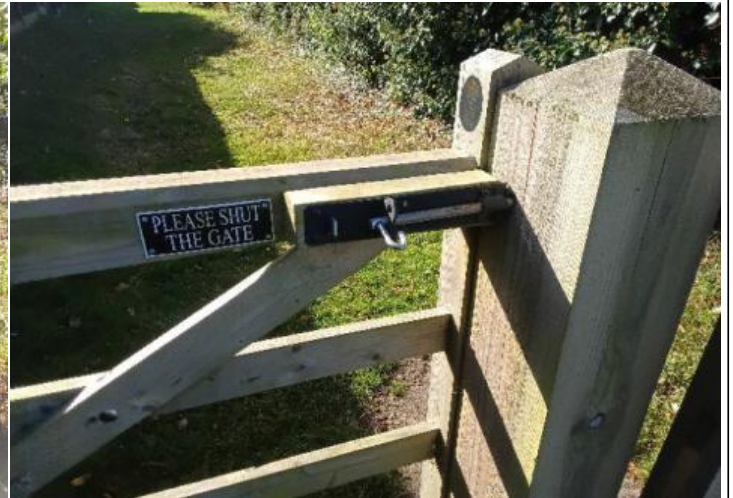
Item: Gates - Gate - Combination
Manufacturer: Not Identified

Finding: There is no padlock on the maintenance gate

Action: Provide a padlock to secure the gate

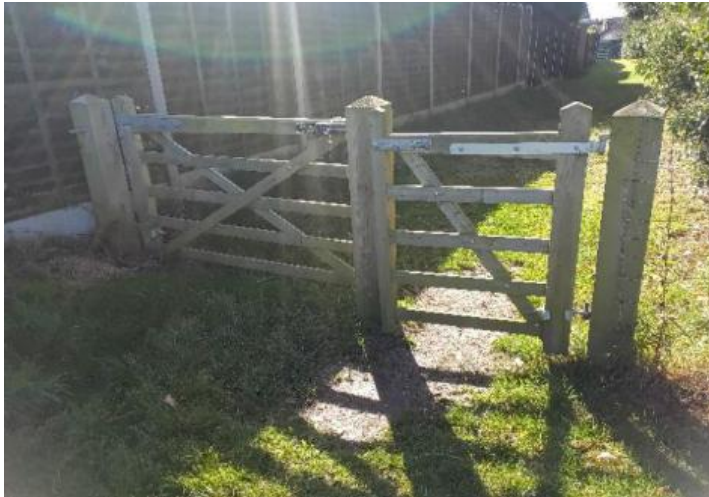
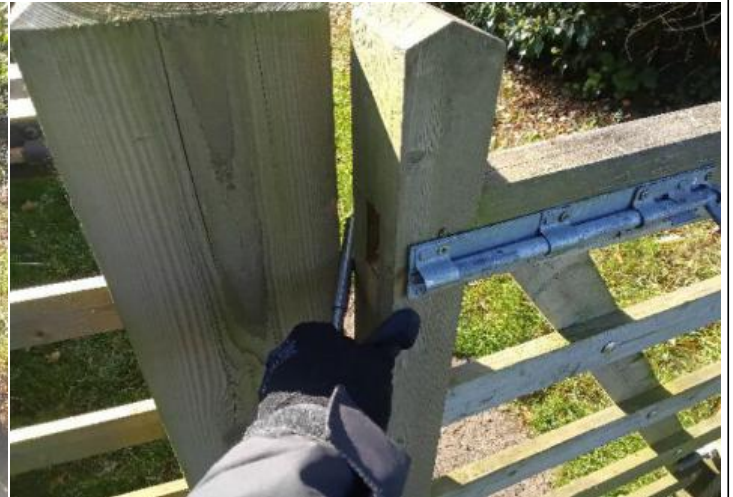
Item: Gates - Gate - Combination
Manufacturer: Not Identified

Finding: There are openings that are less than 12mm that could trap or crush fingers

Action: Provide a 12mm gap throughout full range of motion at both sides of gate

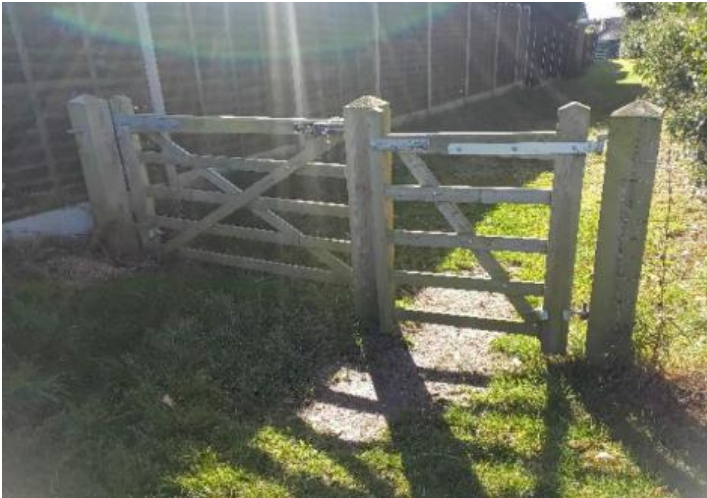
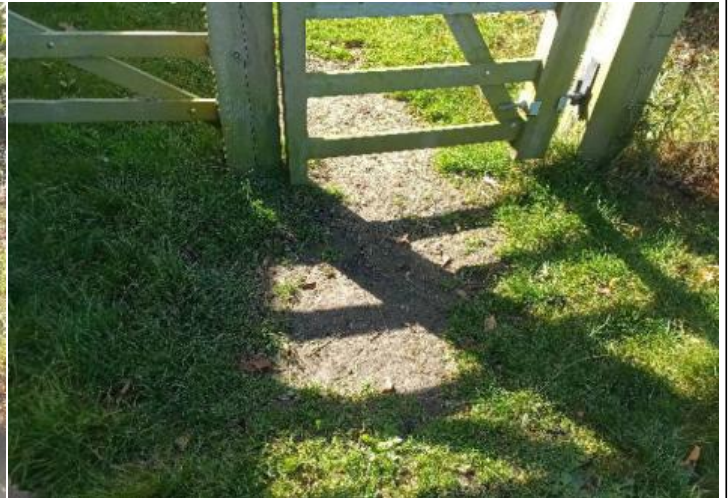
Item: Gates - Gate - Combination
Manufacturer: Not Identified

Finding: The area under the gate has eroded leaving uneven areas, or the concrete foundations exposed, resulting in trip hazards at the entrance/exit to the playground

Action: Reinstate to level with surrounding surfaces

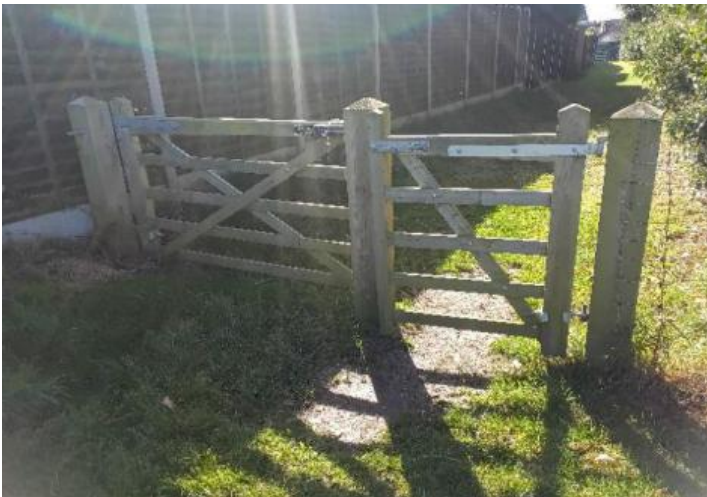
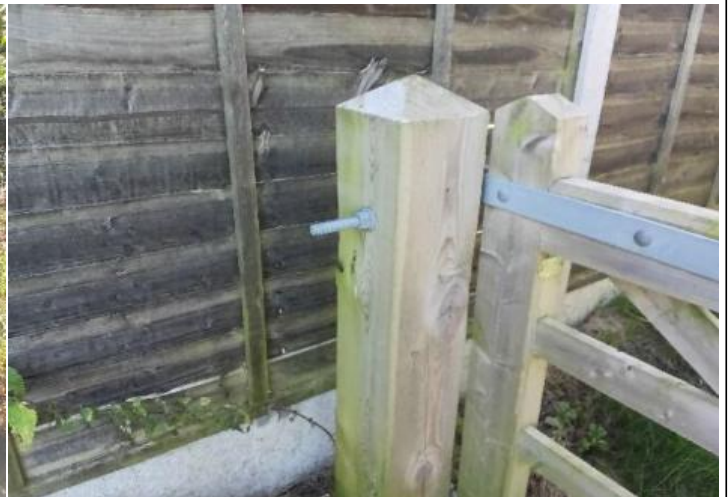
Item: Gates - Gate - Combination
Manufacturer: Not Identified

Finding: There are projecting bolt thread(s) present

Action: Remove excess thread length and deburr or provide cap

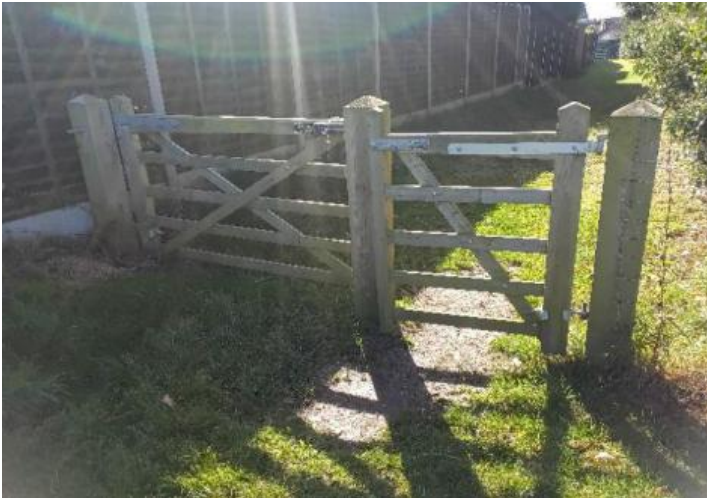
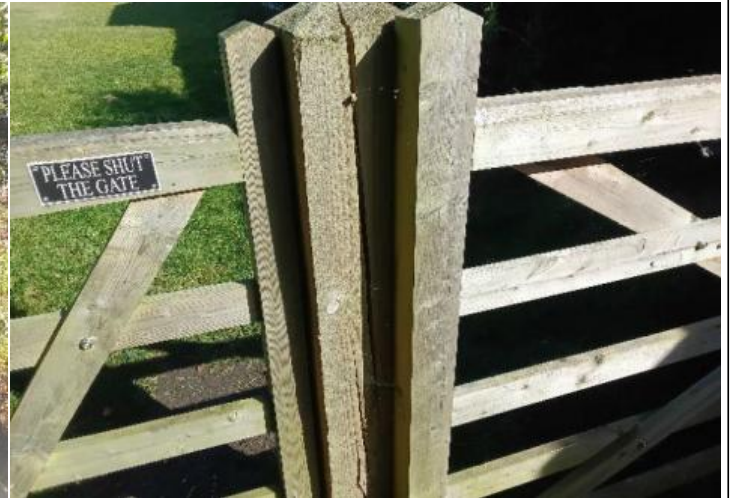
Item: Gates - Gate - Combination
Manufacturer: Not Identified

Finding: The timber has a number of splits/shakes or air cracks and this may affect the stability or allow water ingress which will accelerate the rotting process
Action: Monitor to ensure the splits do not cross through fixing points of the structure and/or cause any instability

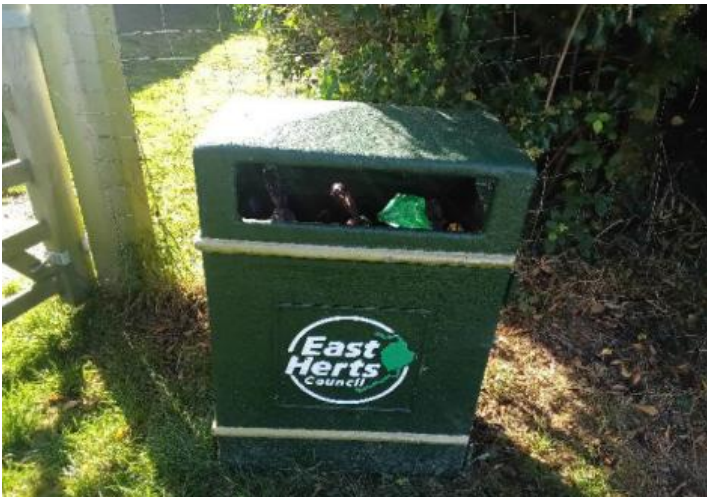
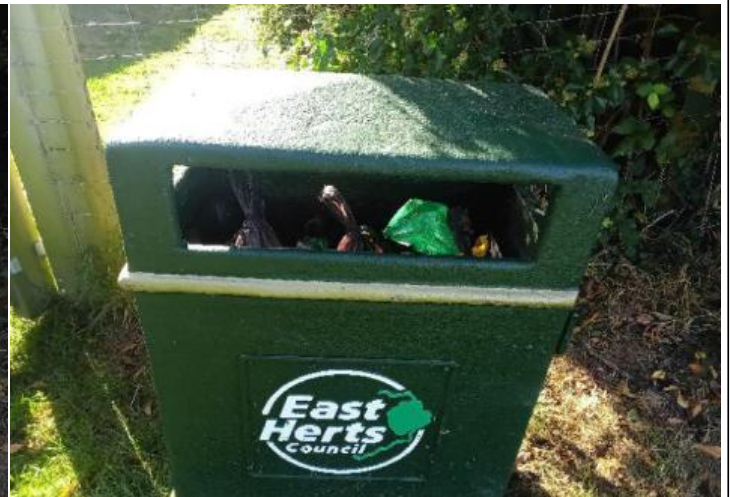
Item: Ancillary Items - Litter Bin
Manufacturer: Not Identified

Finding: The litter bin is full
Action: Empty and review the collection routine

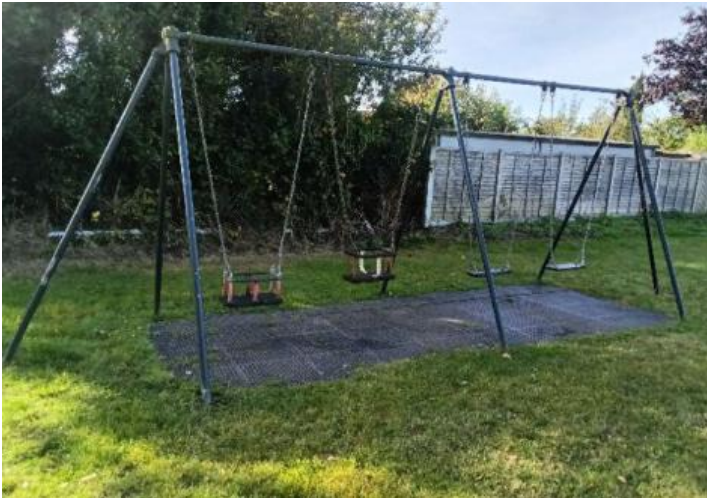
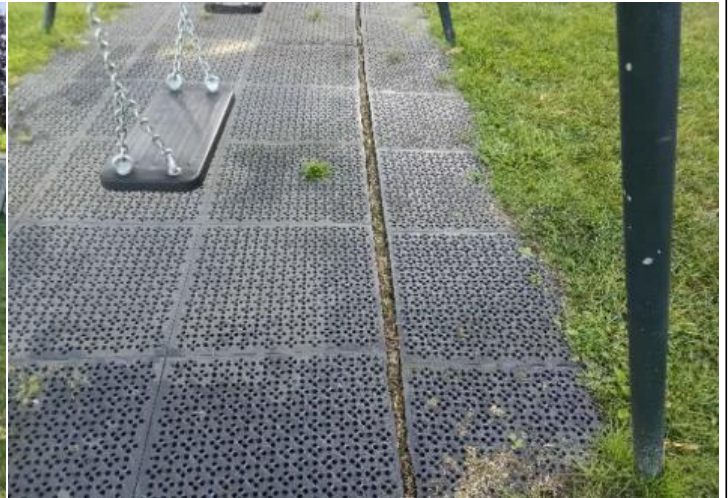
Item: Swings - 2 Bay (2 Flat, 2 Cradle)
Manufacturer: Wicksteed Playgrounds

Finding: There are gaps opening between the grass mat tiles

Action: Provide additional ties or secure / reinstate surface tiles

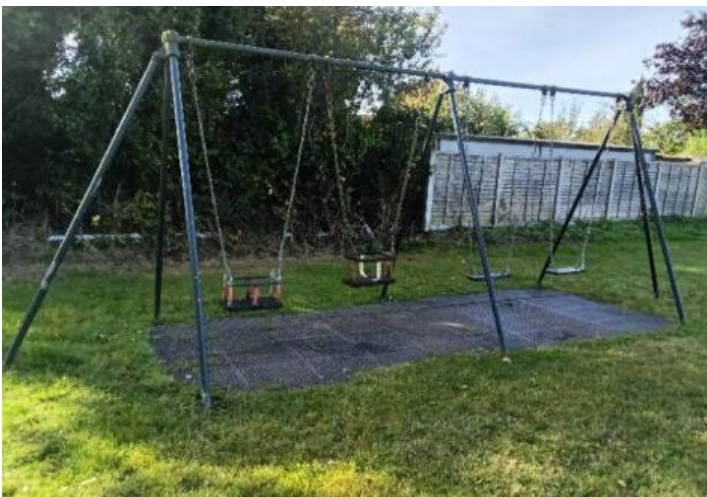
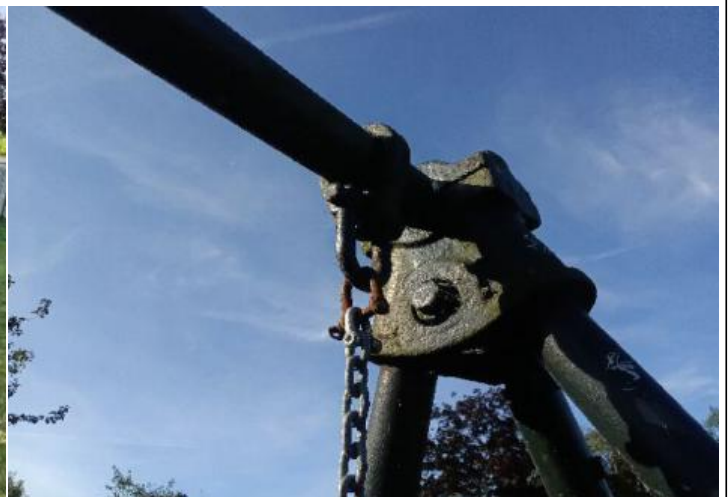
Item: Swings - 2 Bay (2 Flat, 2 Cradle)
Manufacturer: Wicksteed Playgrounds

Finding: The bushes are showing signs of wear

Action: Monitor for any further deterioration and replace as required

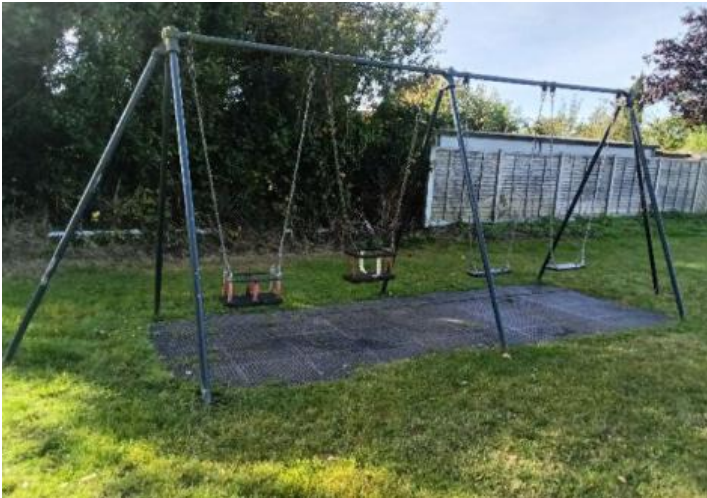
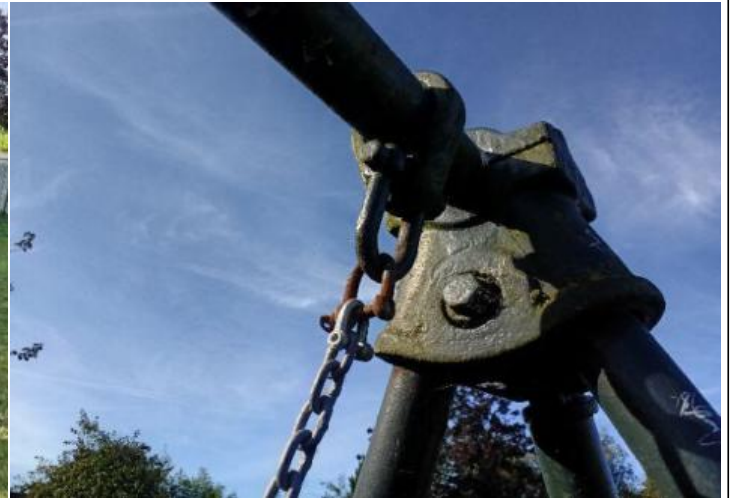
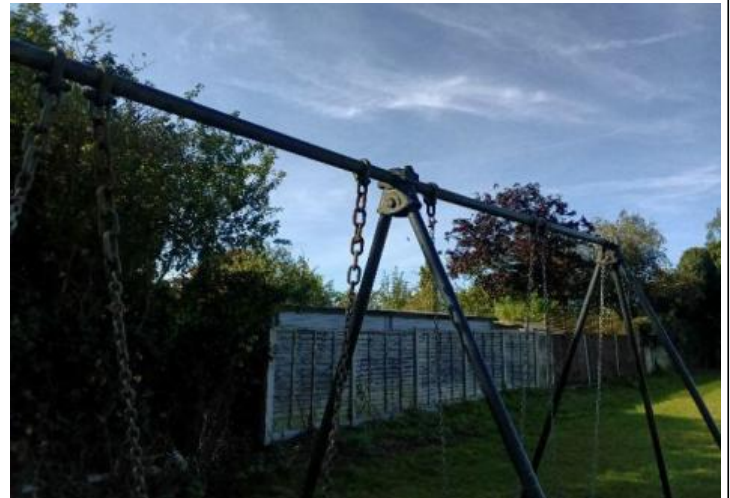
Item: Swings - 2 Bay (2 Flat, 2 Cradle)
Manufacturer: Wicksteed Playgrounds

Finding: There is some wear to the shackles.

Action: Monitor for any further deterioration and replace when 40% worn

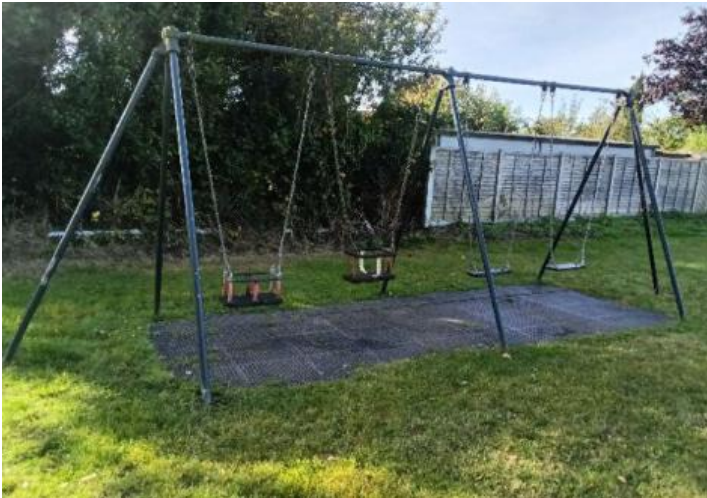
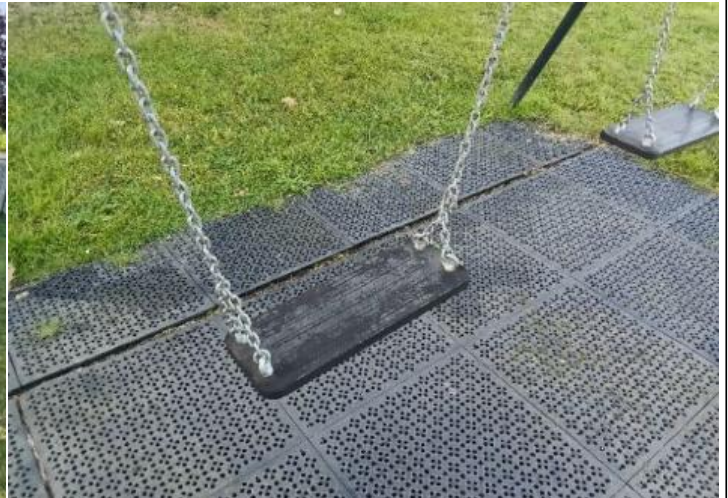
Item: Swings - 2 Bay (2 Flat, 2 Cradle)
Manufacturer: Wicksteed Playgrounds

Finding: The swing seat connectors are loose

Action: Tighten to secure

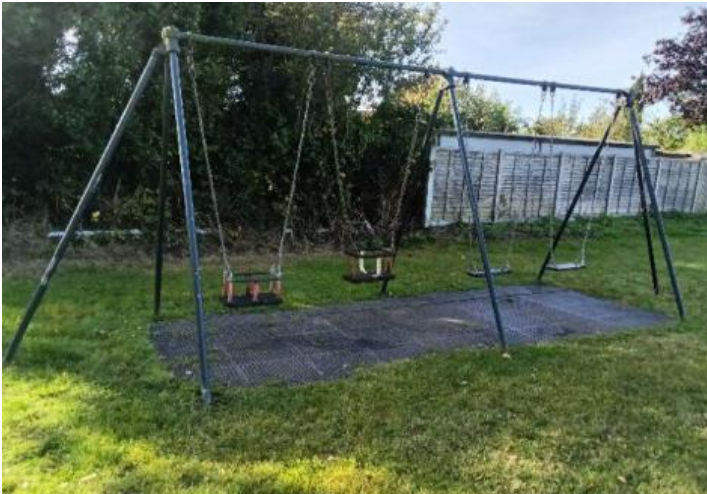
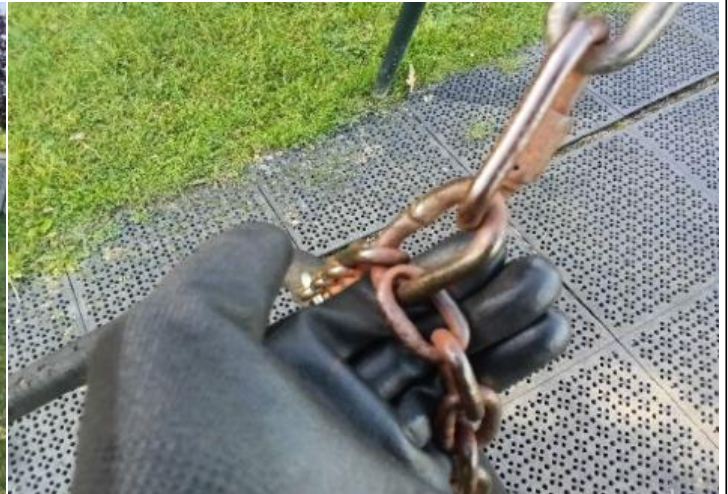
Item: Swings - 2 Bay (2 Flat, 2 Cradle)
Manufacturer: Wicksteed Playgrounds

Finding: The chain links are worn excessively and require renewing

Action: Replace worn chains

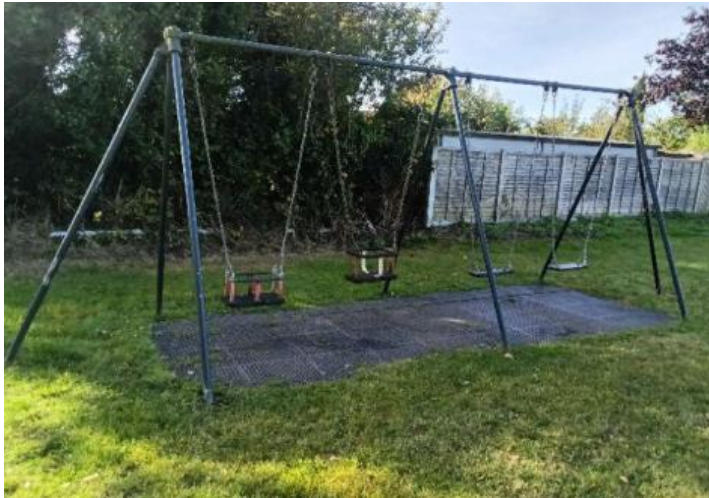
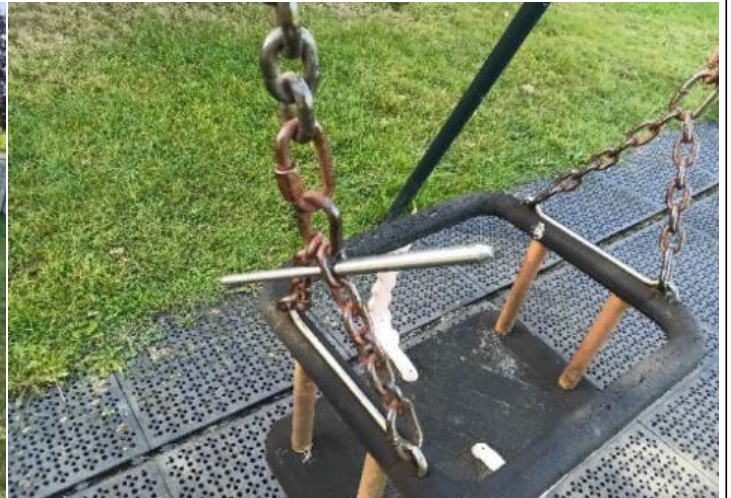
Item: Swings - 2 Bay (2 Flat, 2 Cradle)
Manufacturer: Wicksteed Playgrounds

Finding: The chain openings are in excess of the 8.6mm as recommended by BS EN 1176
Action: Monitor - No remedial work recommended

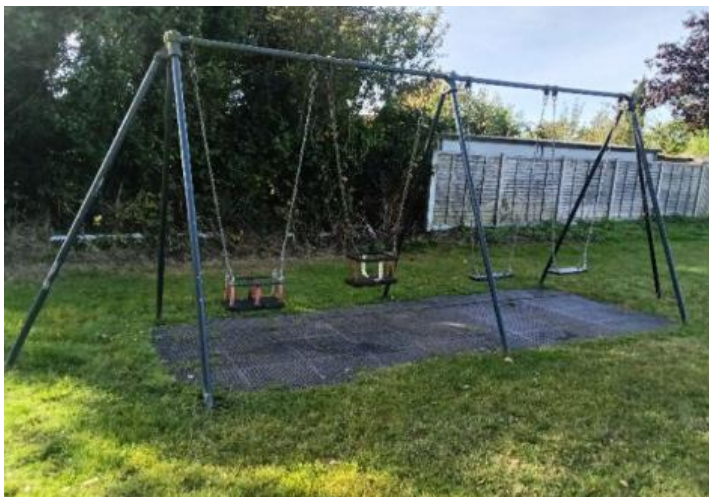
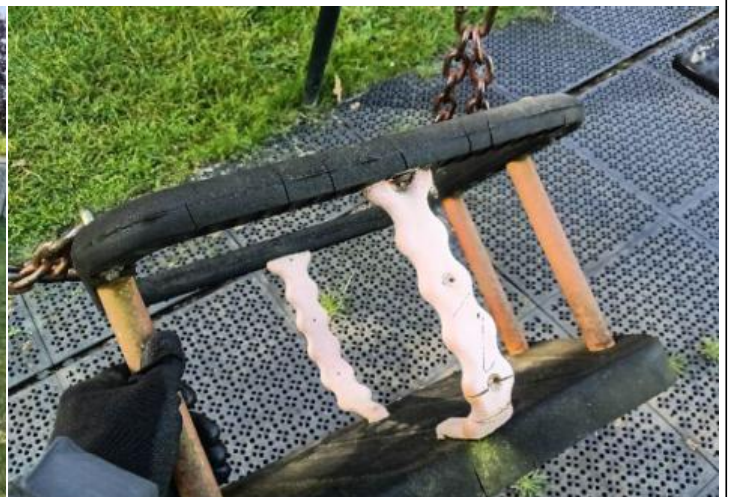
Item: Swings - 2 Bay (2 Flat, 2 Cradle)
Manufacturer: Wicksteed Playgrounds

Finding: The seat has minor damage or wear
Action: Monitor for any further deterioration and replace as required

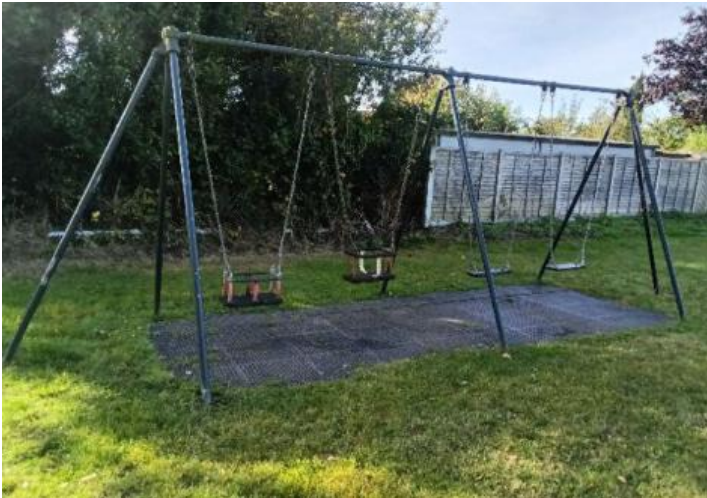
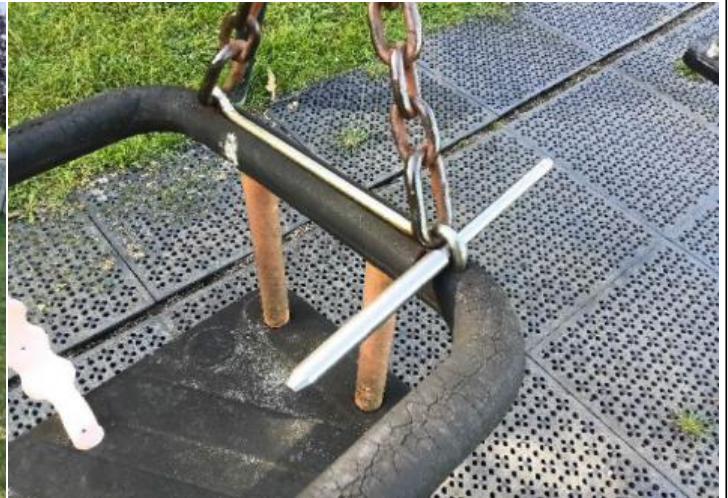
Item: Swings - 2 Bay (2 Flat, 2 Cradle)
Manufacturer: Wicksteed Playgrounds

Finding: The connecting links are in excess of 8.6mm and less than 12mm and fail the requirements of BS EN 1176 Part 1; clause 4.2.13, Chains

Action: Monitor - No remedial work recommended

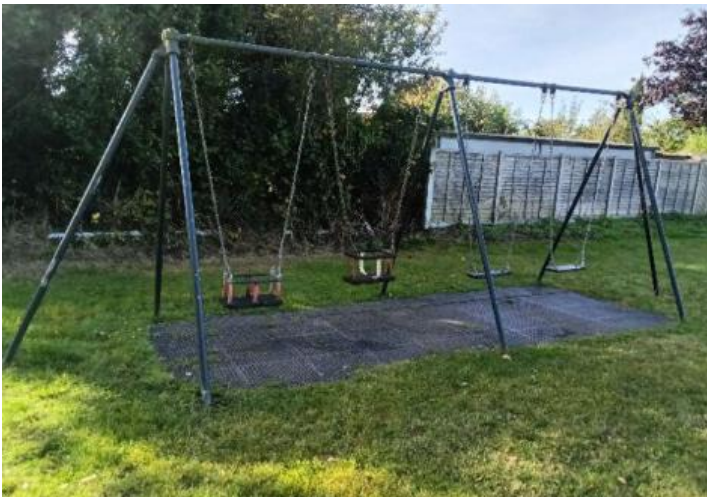
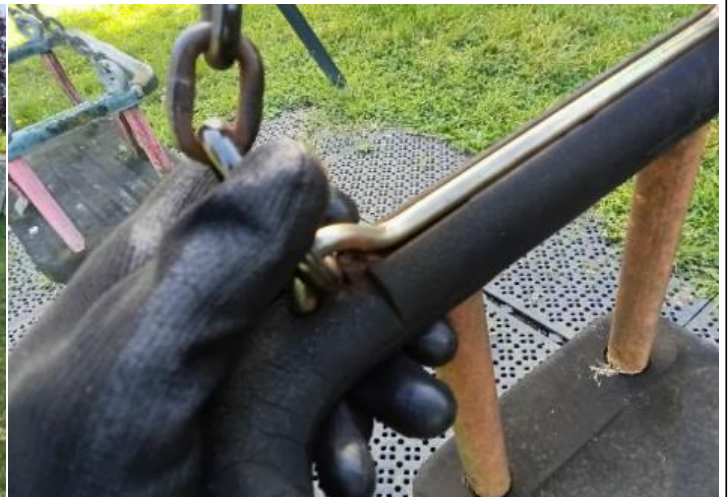
Item: Swings - 2 Bay (2 Flat, 2 Cradle)
Manufacturer: Wicksteed Playgrounds

Finding: The swing seat connectors have some wear present

Action: Monitor for further deterioration and replace when 40% worn

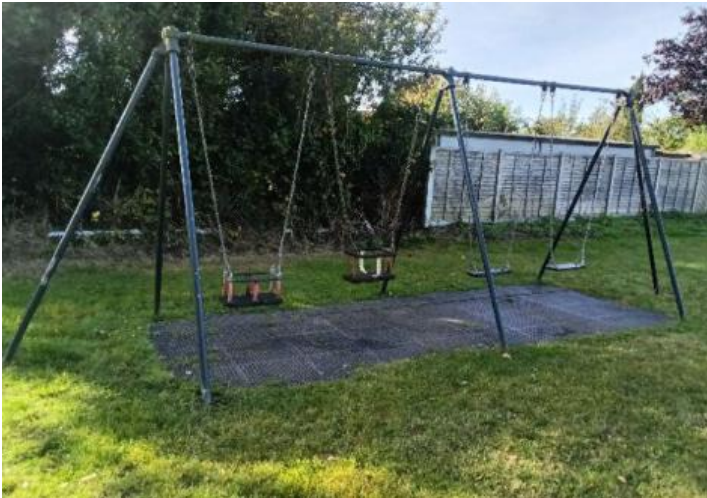
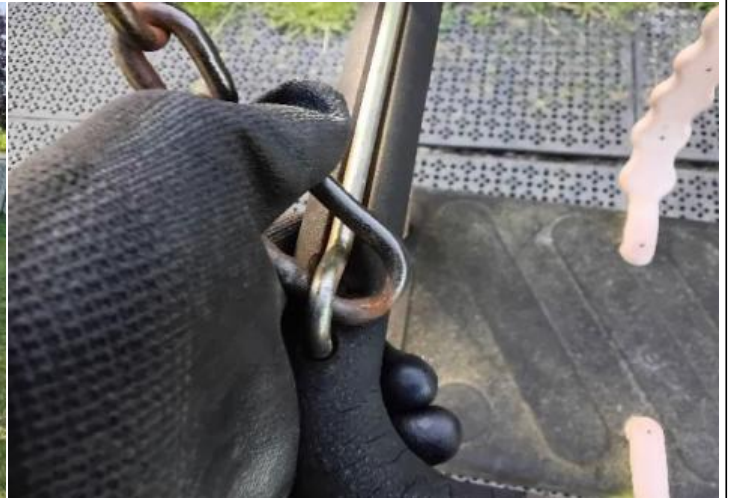
Item: Swings - 2 Bay (2 Flat, 2 Cradle)
Manufacturer: Wicksteed Playgrounds

Finding: There is some wear to the connecting links

Action: Monitor for any further deterioration and replace when 40% worn

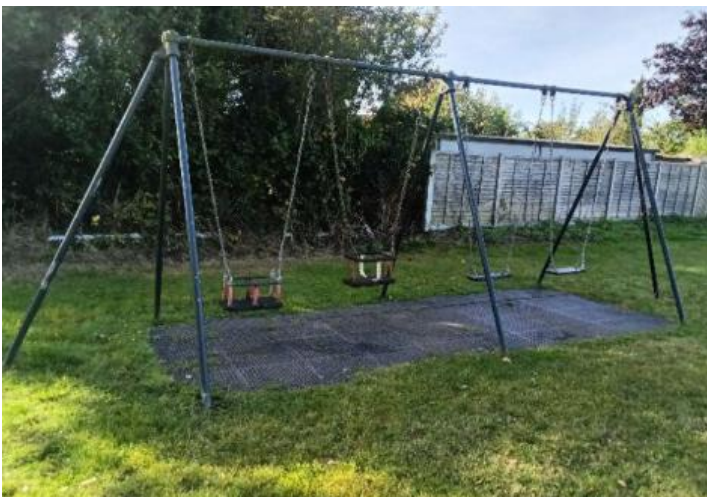
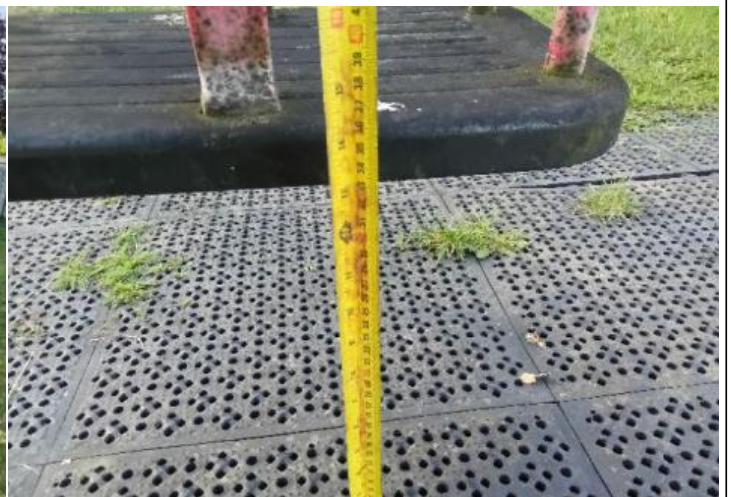
Item: Swings - 2 Bay (2 Flat, 2 Cradle)
Manufacturer: Wicksteed Playgrounds

Finding: The seat clearance from finished surface level to the underside of the seat is too low and does not meet the requirements of BS EN 1176 Part 2 (350mm minimum clearance required)

Action: Adjust seat height/s (400mm-500mm is recommended)

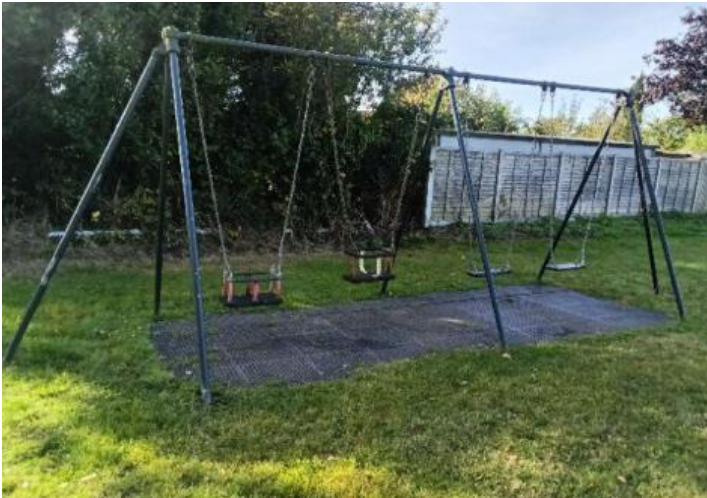
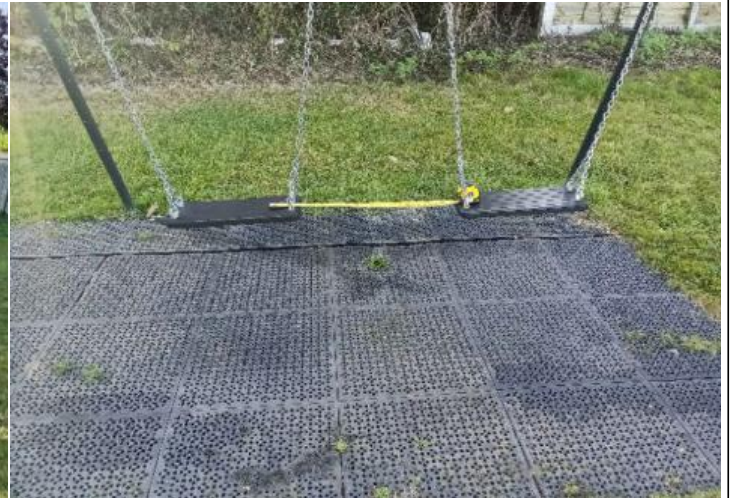
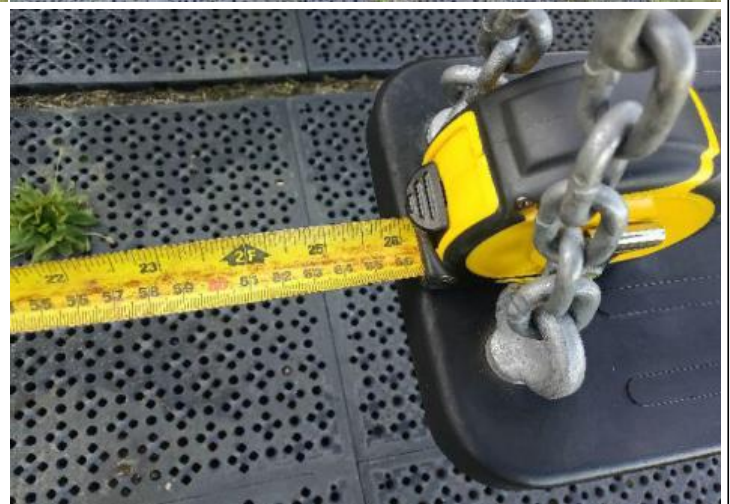
Item: Swings - 2 Bay (2 Flat, 2 Cradle)
Manufacturer: Wicksteed Playgrounds

Finding: The seats are too close to each other as defined in BS EN 1176 Part 2; this is a low risk failure and no remedial action is required
Action: Monitor - No remedial work recommended

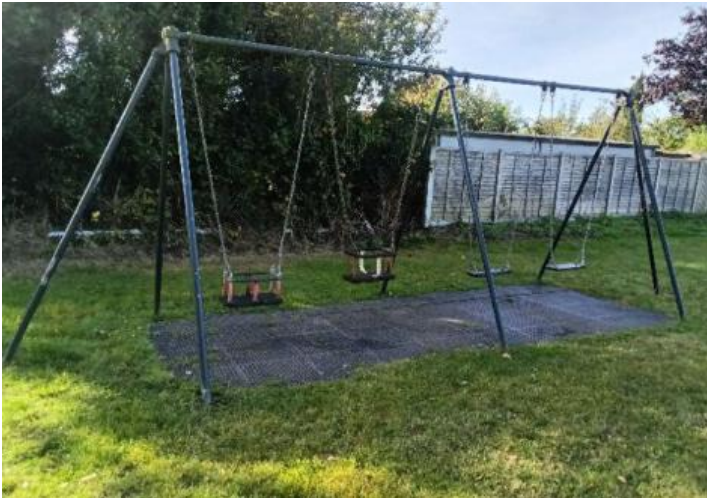
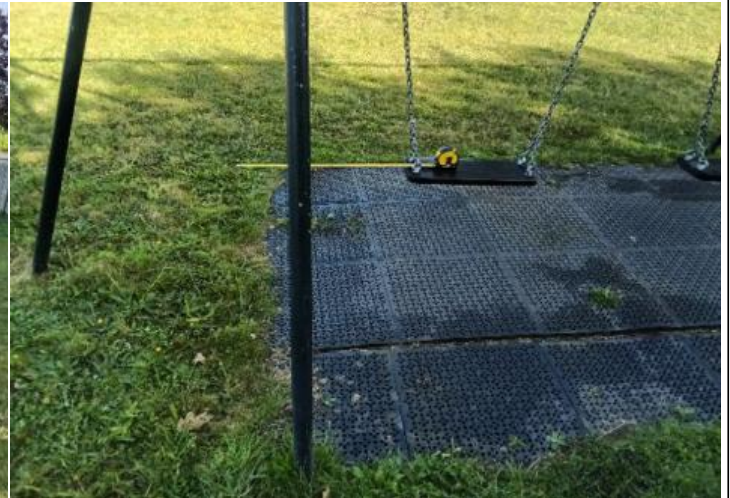
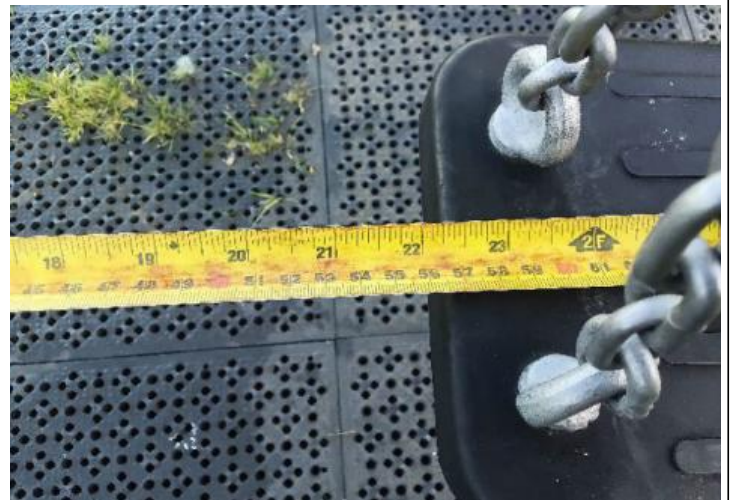
Item: Swings - 2 Bay (2 Flat, 2 Cradle)
Manufacturer: Wicksteed Playgrounds

Finding: The seats are too close to the frame as defined in BS EN 1176 Part 2; this is a low risk failure and no remedial action is required

Action: Monitor - No remedial work recommended

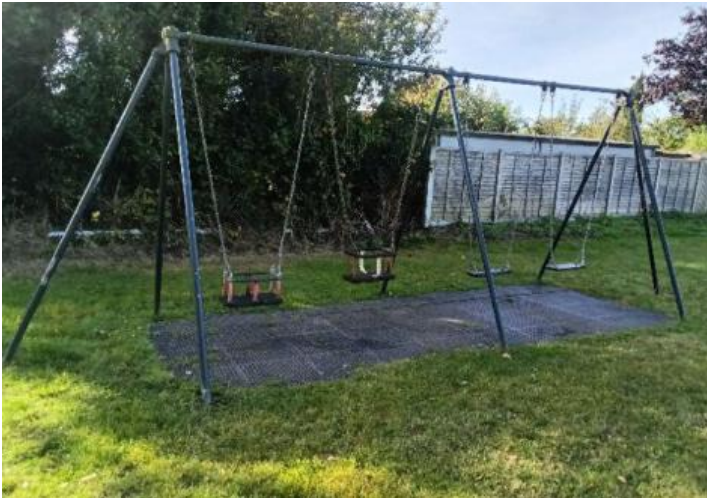
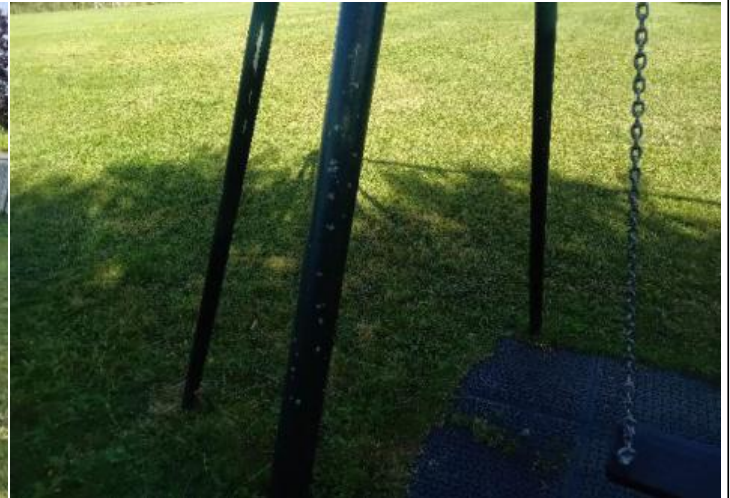
Item: Swings - 2 Bay (2 Flat, 2 Cradle)
Manufacturer: Wicksteed Playgrounds

Finding: The paint is flaking off the metalwork

Action: Rub down and re-paint

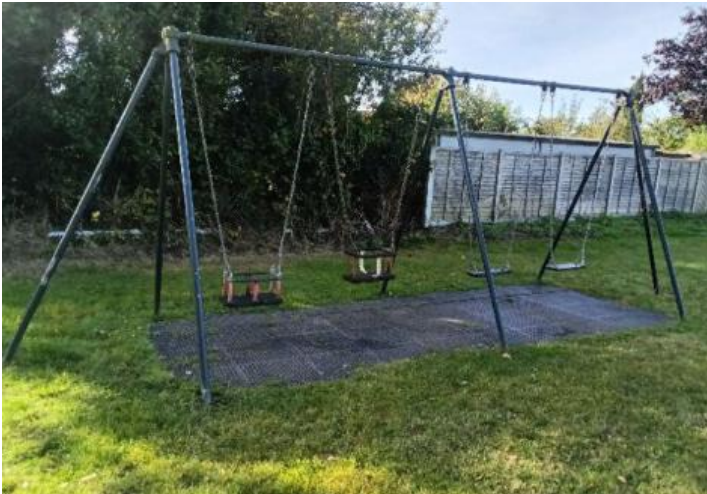
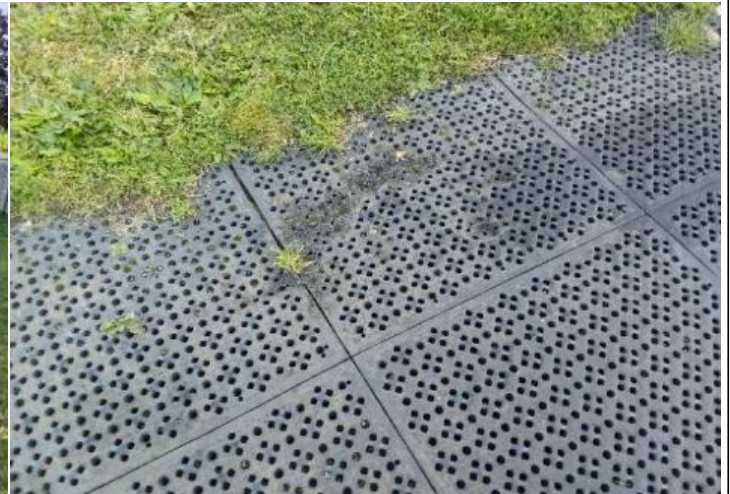
Item: Swings - 2 Bay (2 Flat, 2 Cradle)
Manufacturer: Wicksteed Playgrounds

Finding: There is some evidence of fire damage to the surfacing

Action: Monitor for any further deterioration and repair as required

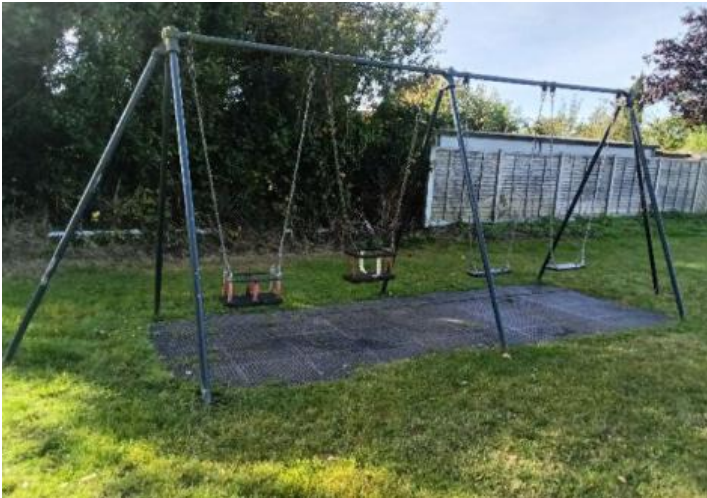
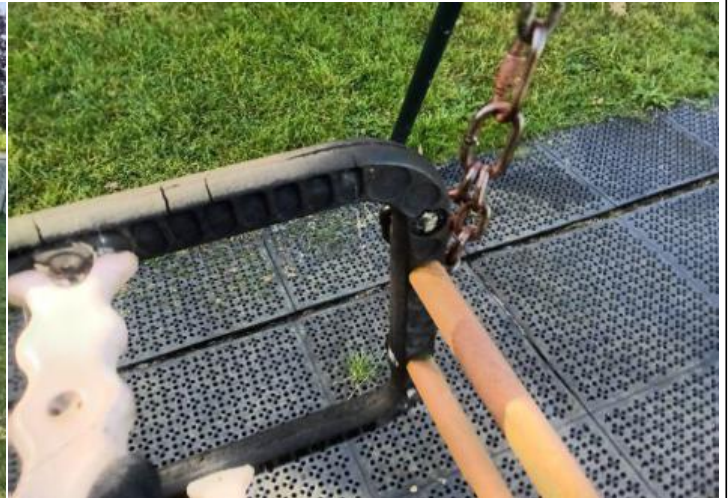
Item: Swings - 2 Bay (2 Flat, 2 Cradle)
Manufacturer: Wicksteed Playgrounds

Finding: There are caps missing from the underside of the seats

Action: Replace missing caps under the seats

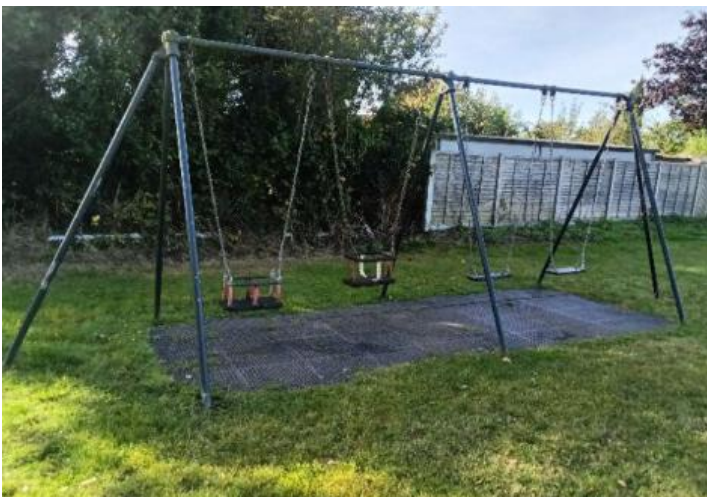
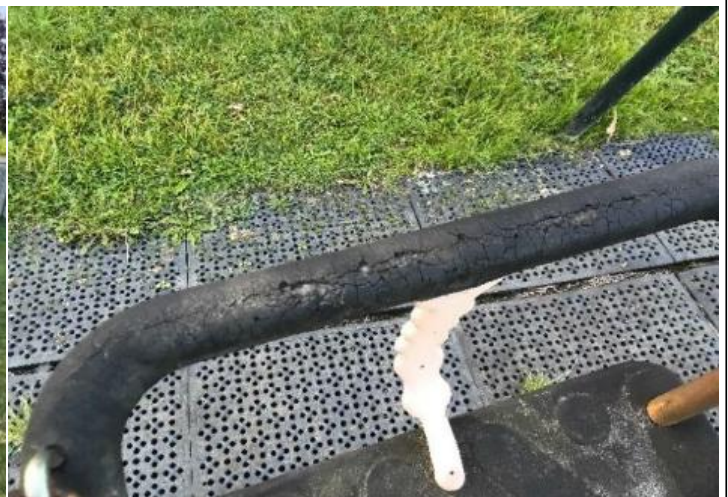
Item: Swings - 2 Bay (2 Flat, 2 Cradle)
Manufacturer: Wicksteed Playgrounds

Finding: The swing seat frames are corroding

Action: Monitor for any further deterioration and replace as required
