Annual Inspection

East Hertfordshire District Council

Tonwell Recreation Ground (Bengeo PC)

Inspection Ref: 2475598

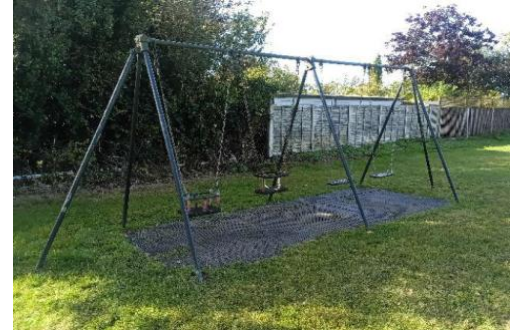
Item: Site General
Manufacturer: Owner/Operator
Surface Type: N/A
Item Quantity: 1
Equipment Compliance: N/A
Surface Area Compliance: N/A

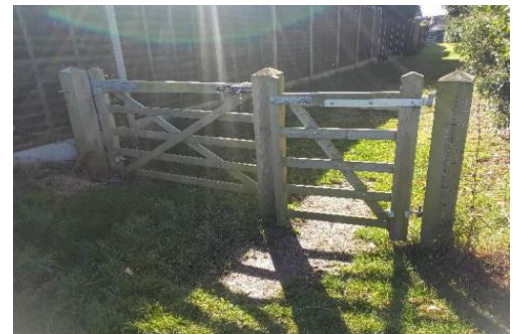
Item: Gate - Combination
Manufacturer: Not Identified
Surface Type: Grass
Item Quantity: 1
Equipment Compliance: N/A
Surface Area Compliance: N/A

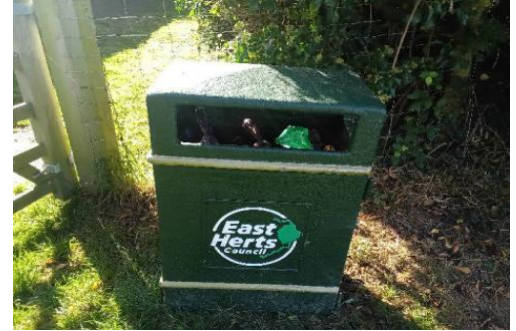
Finding 1

Item: Litter Bin
Manufacturer: Not Identified
Surface Type: Grass
Item Quantity: 1
Equipment Compliance: N/A
Surface Area Compliance: N/A

The litter bin is full - Empty and review the collection routine

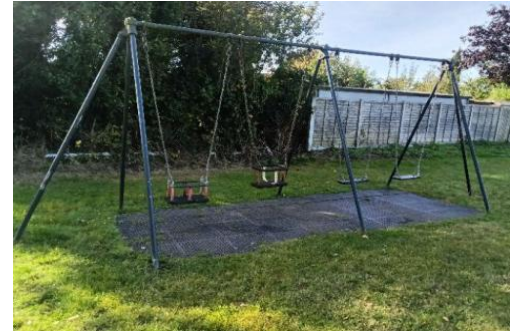
Item: 2 Bay (2 Flat, 2 Cradle)
Manufacturer: Wicksteed Playgrounds
Surface Type: Matta
Item Quantity: 1
Equipment Compliance: No
Surface Area Compliance: Yes

Finding 1	Finding 2
There are gaps opening between the grass mat tiles - Provide additional ties or secure / reinstate surface	The bushes are showing signs of wear - Monitor for any further deterioration and replace as required
Finding 3	Finding 4
There is some wear to the shackles. - Monitor for any further deterioration and replace when 40% worn	The swing seat connectors are loose - Tighten to secure
Finding 5	Finding 6
The chain links are worn excessively and require renewing - Replace worn chains	The chain openings are in excess of the 8.6mm as recommended by BS EN 1176 - Monitor - No remedial work recommended
Finding 7	Finding 8
The seat has minor damage or wear - Monitor for any further deterioration and replace as required	The connecting links are in excess of 8.6mm and less than 12mm and fail the requirements of BS EN 1176 Part 1; clause 4.2.13, Chains - Monitor - No remedial work recommended

The swing seat frames are corroding - Monitor for any further deterioration and replace as required
